# *Quakesmart Testimonial*

# Marvin Windows & Doors

- ❑ Ripley, TN
- ❑ Manufacturing Facility
- ❑ 660 Associates
- ❑ 3-shifts

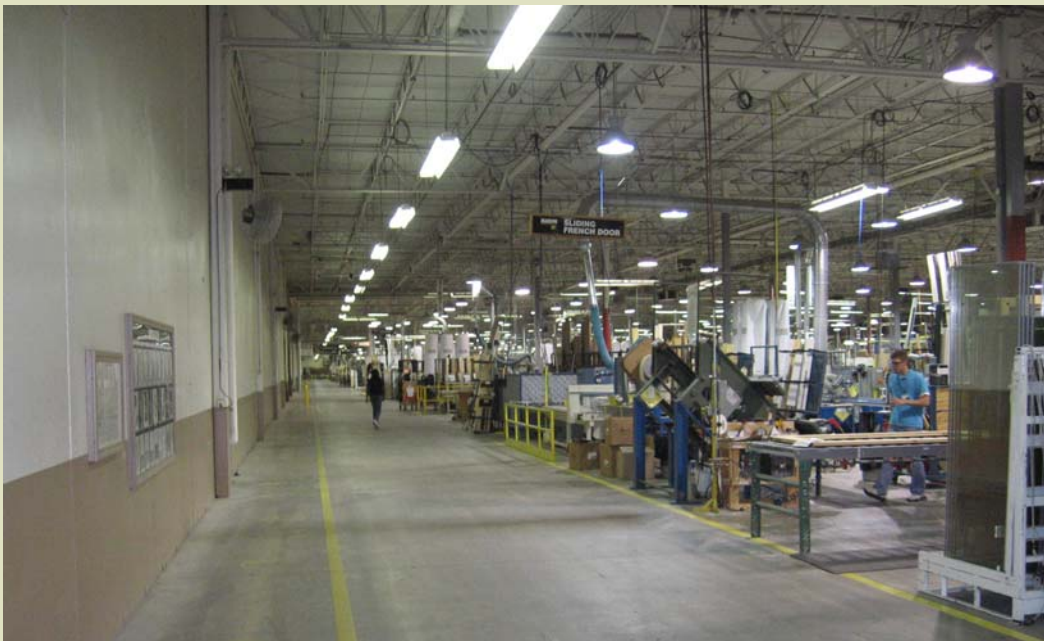
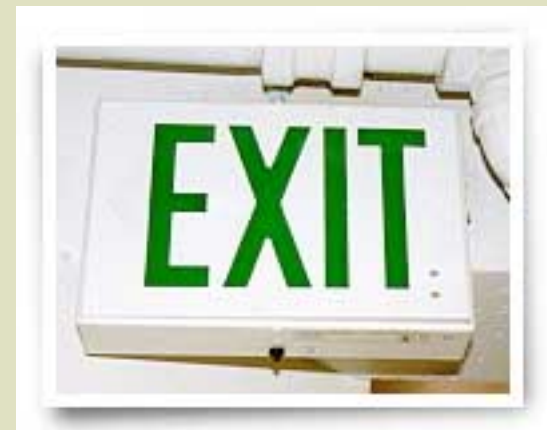
# Building Evacuation

- ❑ Exit markers difficult to see. Installed new signs.
- ❑ Evaluated egress routes and labeling.

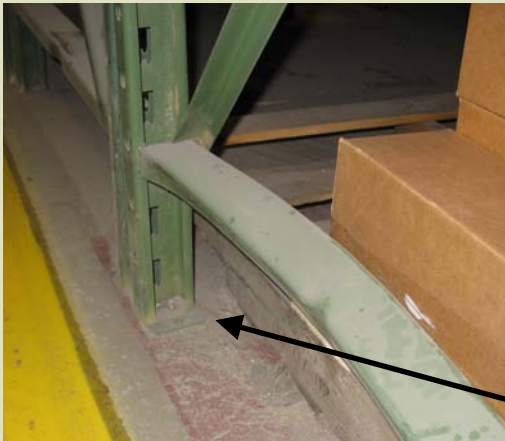
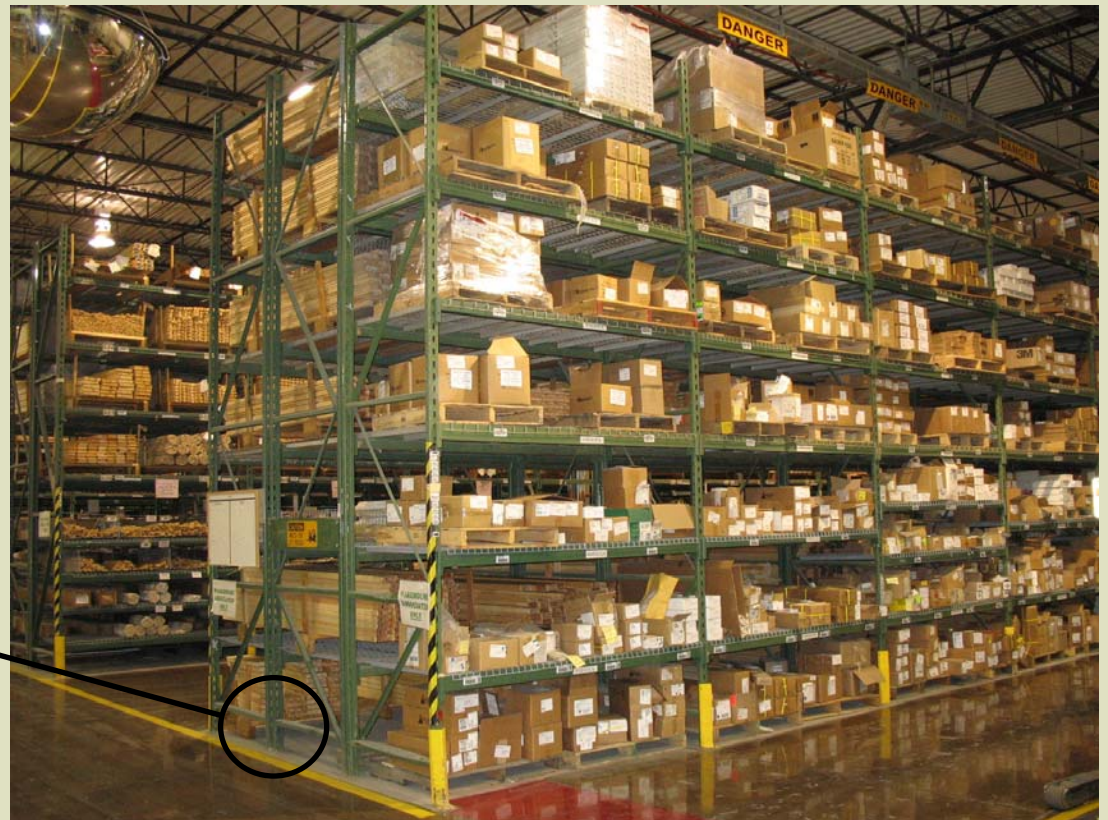
# Nonstructural Life-Safety Risks

- Addressed life-safety risks throughout the plant.
