# *Quakesmart Testimonial*

# Marvin Windows & Doors

- ❑ Ripley, TN
- ❑ Manufacturing Facility
- ❑ 660 Associates
- ❑ 3-shifts

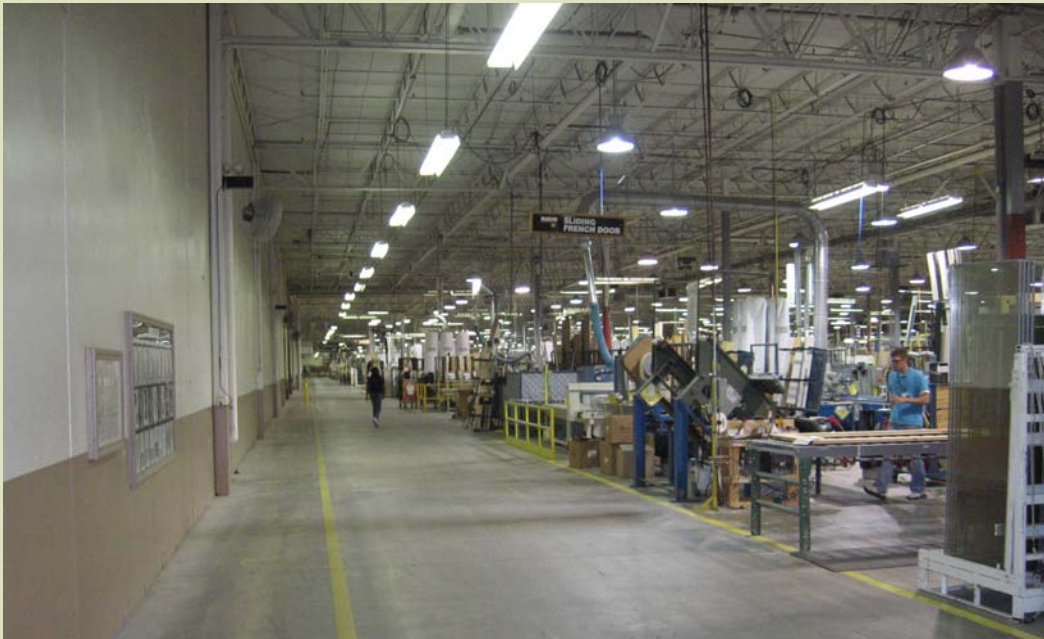
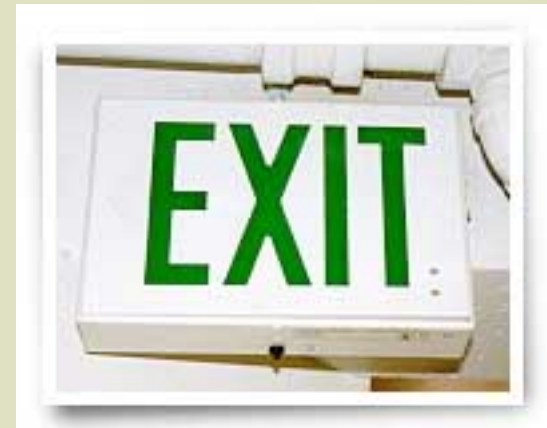
- ❑ Exit markers difficult to see. Installed new signs.
- ❑ Evaluated egress routes and labeling.

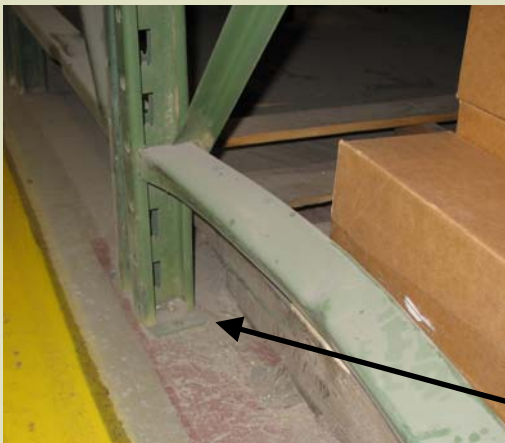
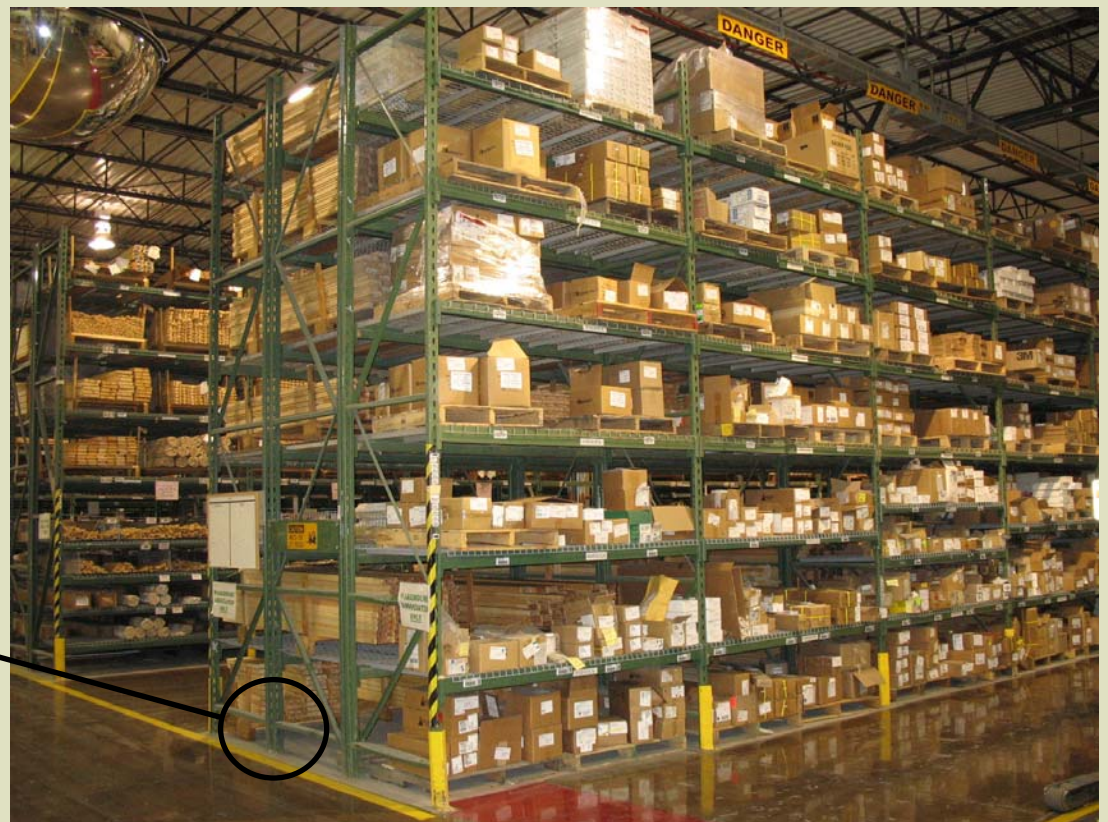
- Addressed life-safety risks throughout the plant.
